Shelter from the Storm

S P F a n d t h e
h u r r i c a n e s o f F l o r i d a

By Mason Knowles and
Roger Morrison, PE, RRC

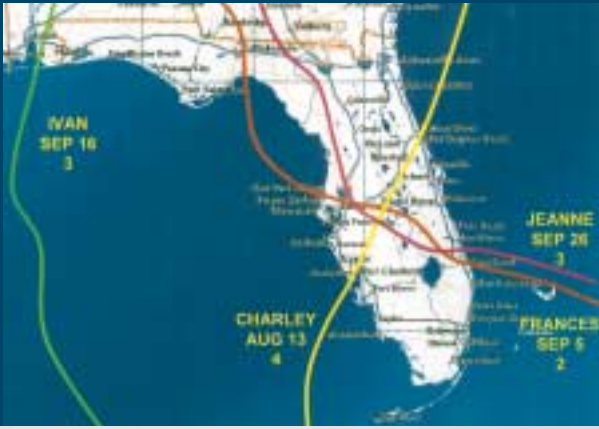
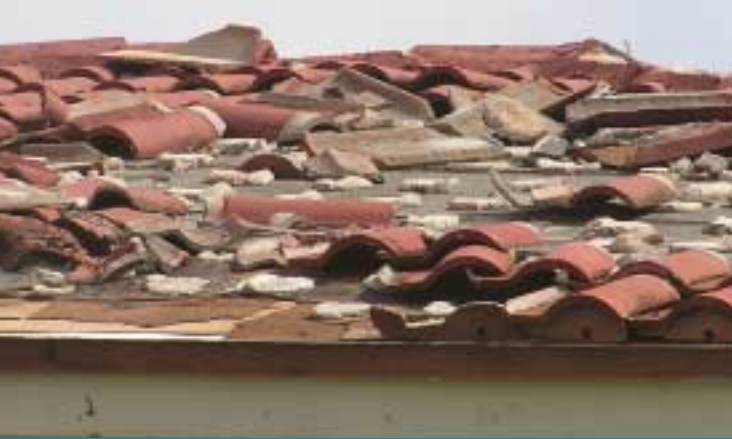
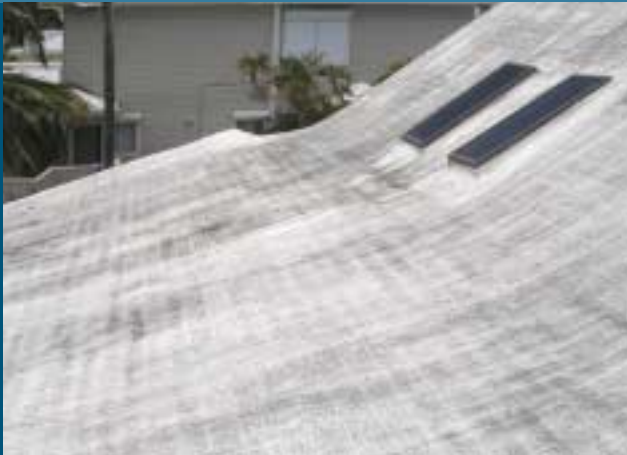
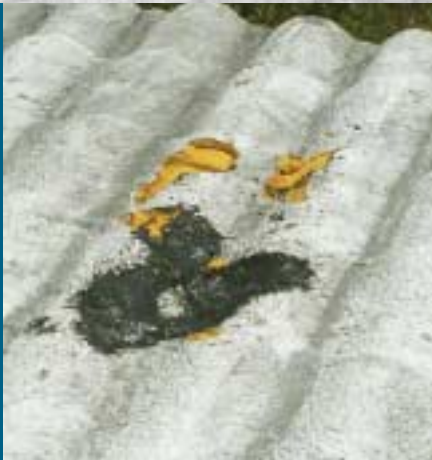
Roof decks encountering high winds can be damaged as a result of high-pressure differentials. When a door or window fails, this pressurization's effect on the roof increases, with dire consequences—the deck (and the roofing membrane) can quite literally blow up. Using SPF on the deck underside could have potentially helped.

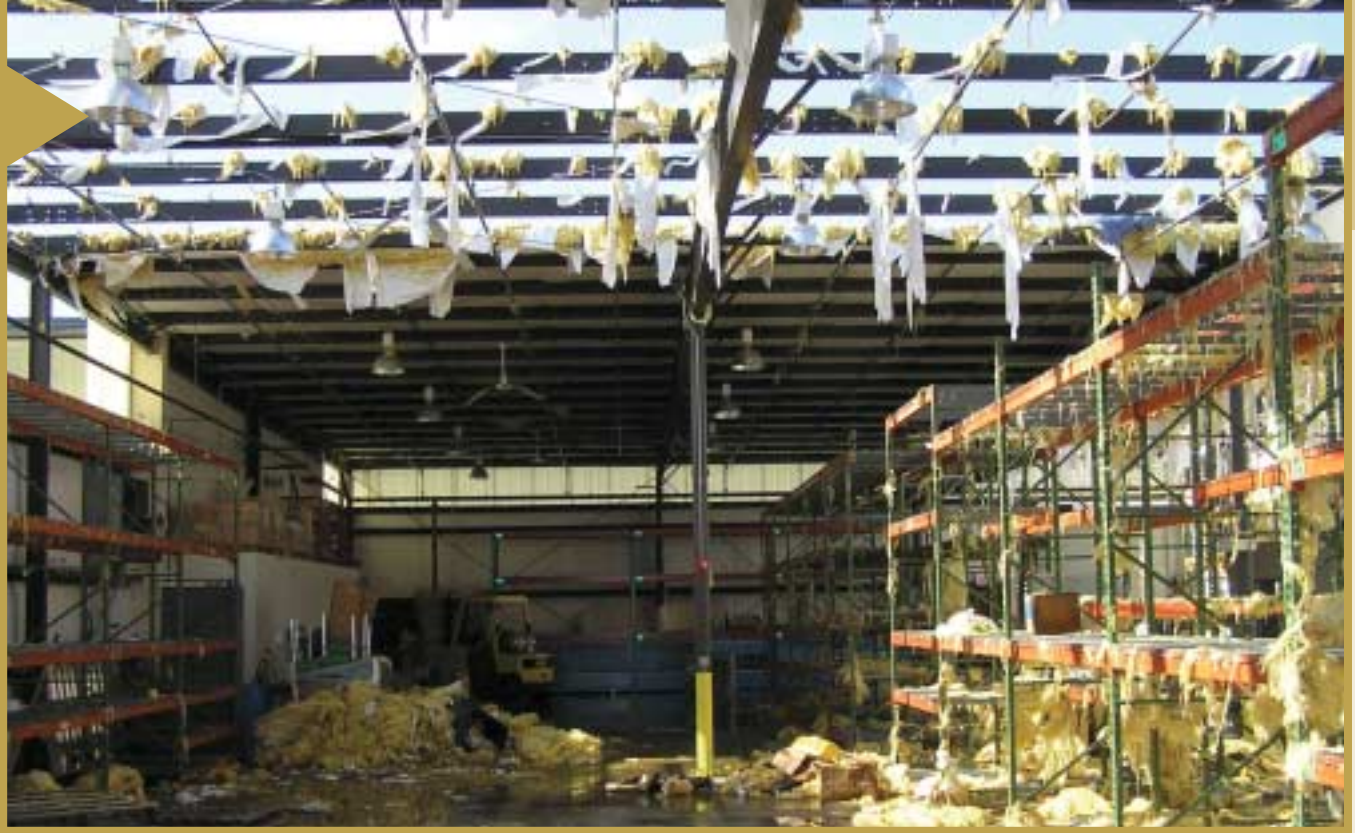
In the summer of 2004, four hurricanes ripped through Florida, causing rampant damage. However, the qualities of spray polyurethane foam (SPF) and other plastic adhesives meant some roofs survived largely unscathed and prevented many materials from becoming missile debris.
