The Use of Closed-Cell Spray Polyurethane Foam (ccSPF) to Enhance the Structural Properties of Wall and Roof Assemblies

By Mason Knowles

This article discusses field observations and research that document the ability of closed-cell spray polyurethane foam (ccSPF)¹ to add structural strength to roof and wall assemblies.

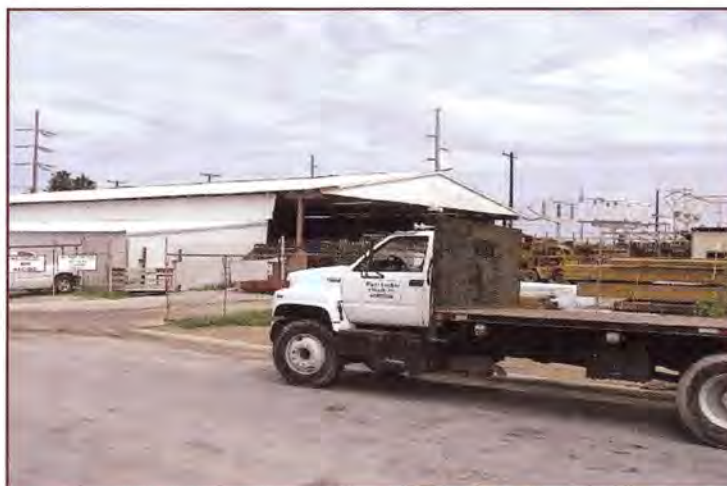
Figure 2 – The author installed the old metal roof on this building in 1980. A new metal roof was installed in 2008 on the right side of the building.

Figure 2 shows White's Lumber's open-end, post-frame-construction building. New metal was installed to half of the building (right side of the photo) in 2008, and the old metal originally installed in 1980 is on the left. For close to 30 years, there were no significant wind events in the area.

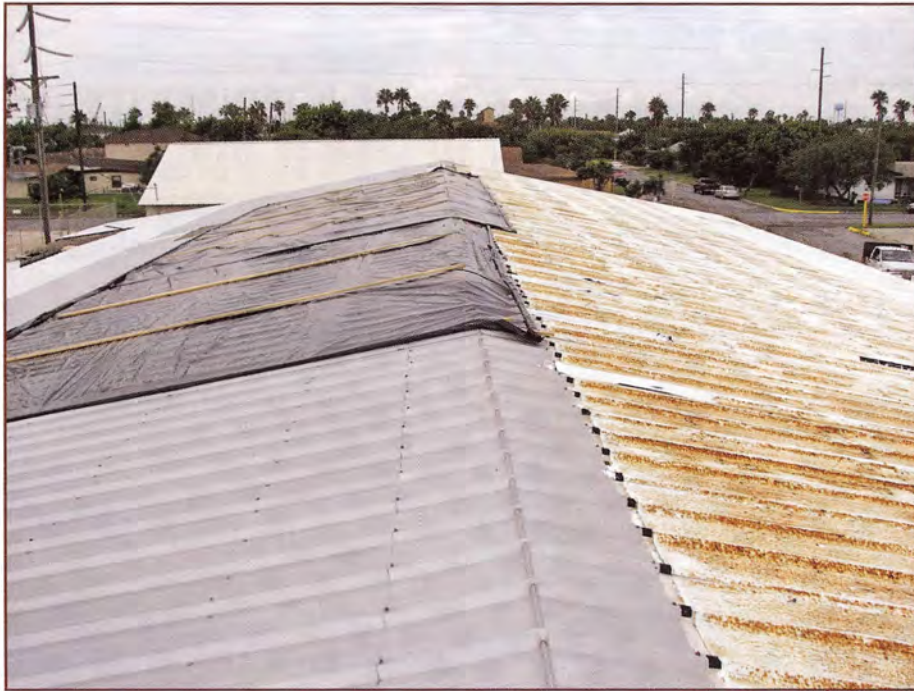
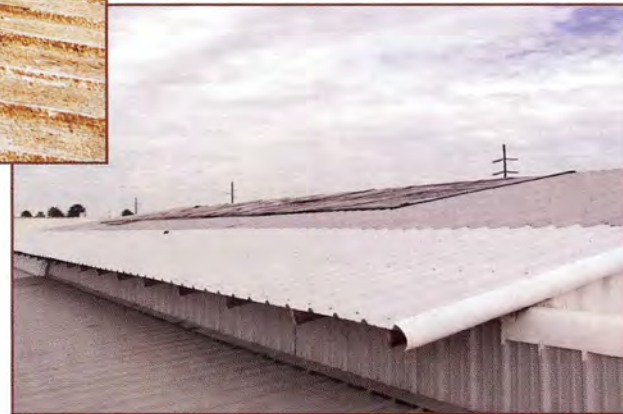
Figures 3 (left) and 4 (below) – Half of the roof blew off of White’s Lumber during Hurricane Dolly.

Lumber and Supply lost half of its roof, as shown in *Figures 3* and *4*. But something looks strange, doesn’t it? The left side of the building has a new metal skin installed in 2008, while the right side has metal panels that are over 29 years old. As can be seen, the new metal blew off in the storm, while the old metal remained in place. Both are 29-gauge metal² with similar fasteners and fastening patterns (in fact, the new metal portion had a closer fastening pattern than the old section, and both are fastened to the same wood framing).

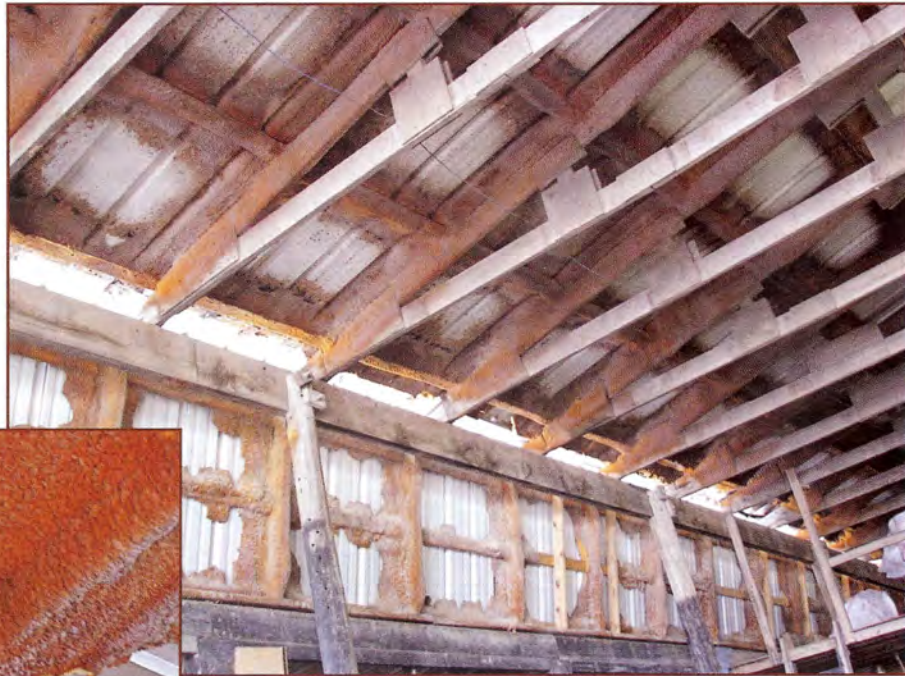
Figure 5 – Old metal secured with ccSPF.

There is a simple explanation. When the metal was replaced in 1980, the owner contracted with the author to install a 2-lb, closed-cell spray foam in a “picture frame” pattern to help secure the metal panels to the wood trusses. Twenty-nine years later, this safety net proved invaluable (*Photo 5*). Unfortunately, when the owner replaced the metal on half of the building in 2008, he could not find an SPF applicator to replace the foam (*Photo 6*). Consequently, high winds blew off major portions of the new metal panels.

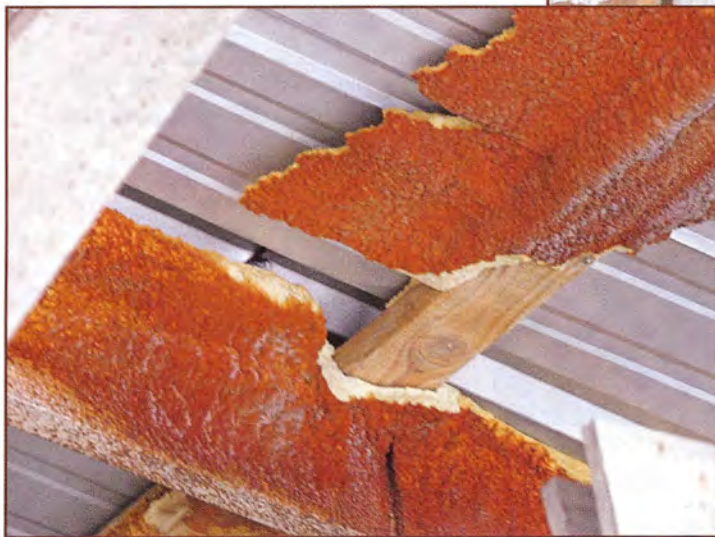
Figure 6 – The ccSPF was removed to install new metal.

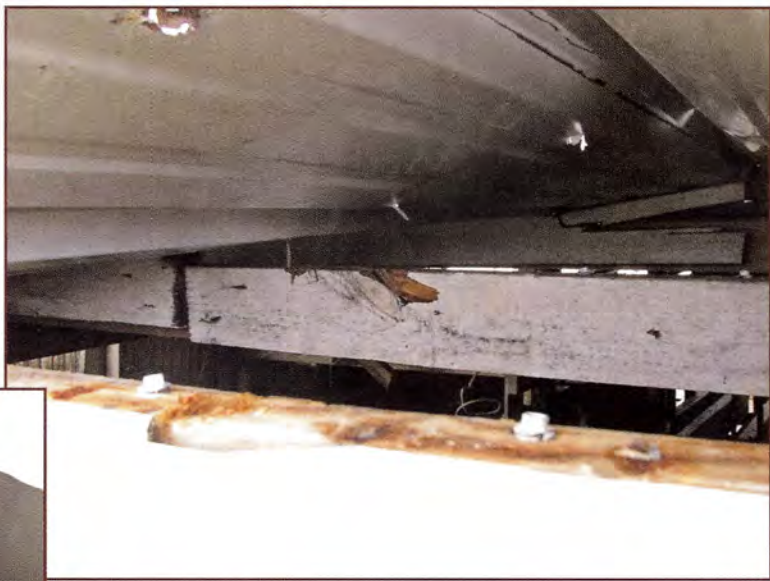
Figures 7 (right) and 8 (below) – Fasteners pulled through the new metal skin where there was no ccSPF to help secure the panels to the wood trusses.

As shown in Figures 7 and 8, the main cause of failure of the new metal skin was pulling of the fasteners through the metal.

2. Since 29 gauge is a low-strength metal sheathing material, it is much more likely that fasteners will pull out of such metal, causing damage in a high-wind event. A thicker sheathing might have survived the storm without damage.
3. Wind-driven debris will typically cause dents, cracks, and gouges to exterior applications of ccSPF. A sealant compatible with the coating can repair small (less than 4 in) mechanical damage. Larger areas of damage can be repaired by removing the damaged foam and replacing it with new foam using high-density foam kits or standard SPF proportioning equipment. Recoating may be required if the damage covers large areas of the structure.
4. Joseph E. Minor, PE, William L. Beason, and Timothy P. Marshall, "Effects of Hurricane Allen on Buildings and Construction," *Proceedings of the Fourth National Conference on Wind Engineering Research*, Seattle, WA, 1981.

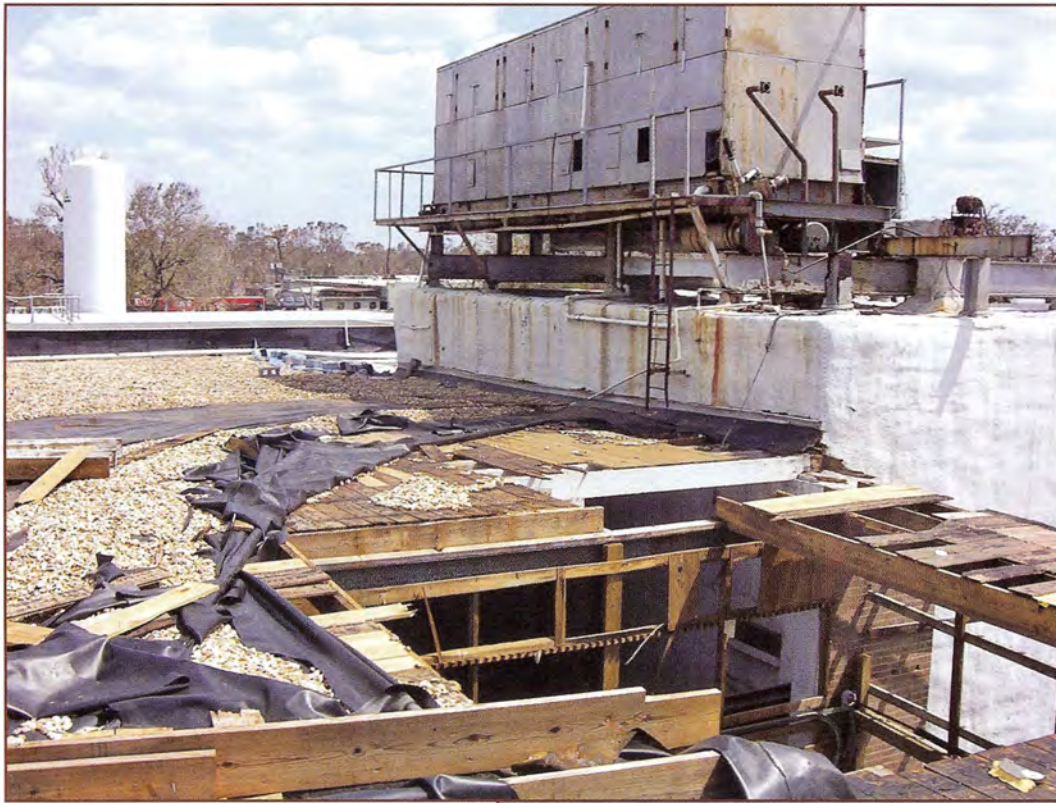
Figure 9 – Internal pressurization during Hurricane Katrina destroyed a tongue-and-groove wood deck at this ice plant.

Figure 10 – The metal building below was connected to the structure shown in Figure 9 and was insulated with ccSPF. It received no damage during Hurricane Katrina.

As shown in Photo 9, internal pressurization destroyed the tongue-and-groove roof deck of this ice plant during Hurricane Katrina. However, the metal building section (depicted in Photo 10) that was insulated with ccSPF and connected to the same structure, survived with no damage.

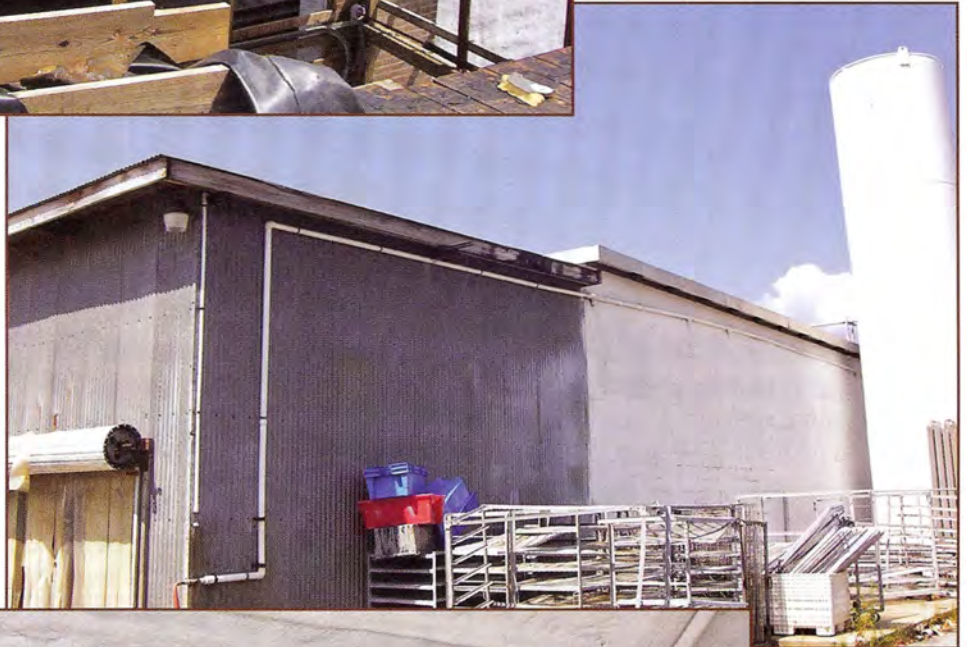
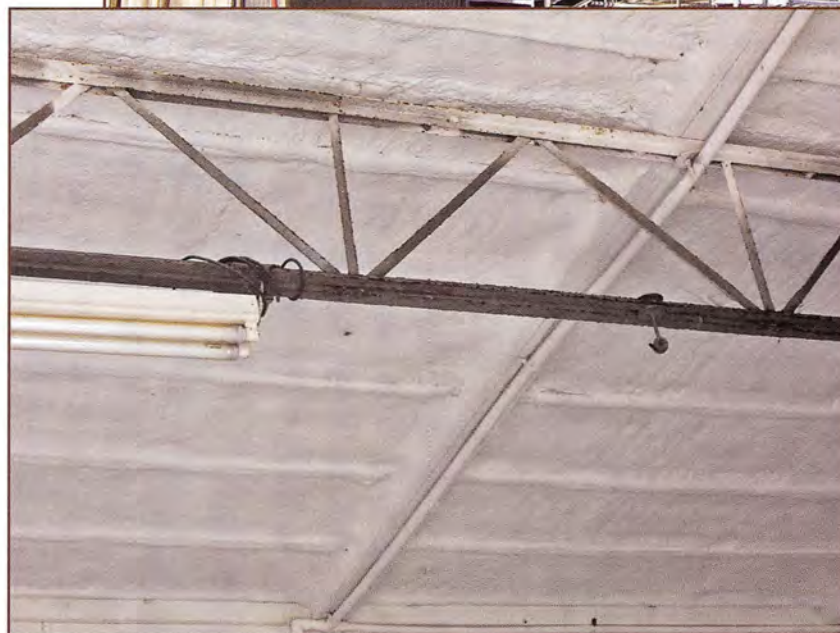
Figure 11 – Foam sprayed against metal roof decking and corrugated metal wall panels.

None of the areas insulated with ccSPF sustained any damage. An interesting observation is that many of the ccSPF-insulated portions of the building were areas that would be considered less structurally sound than other areas (if they were not structurally reinforced with ccSPF). *Figure 11* shows the foam sprayed against metal roof decking and corrugated metal wall panels.

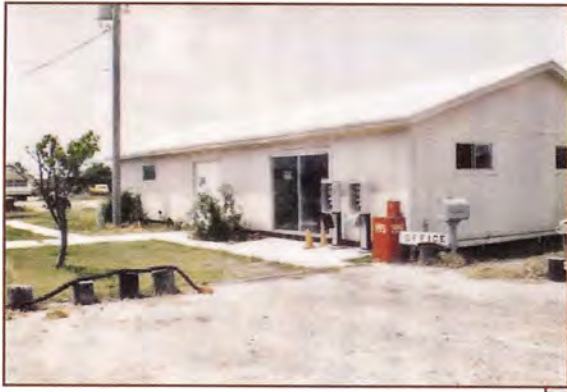
Figure 12 – Port Isabel RV Park, 1979 (before Hurricane Allen).

A recent example of this design is the recreation building at the Port Isabel RV Park. Around 1978, a tropical storm caused damage to the exterior wood cladding, allowing water intrusion into the building. After unsuccessful attempts to correct the problem, the author was contracted to install 1.5 in. of ccSPF to the outside of the entire structure. The application of ccSPF stopped the leaks into the building.

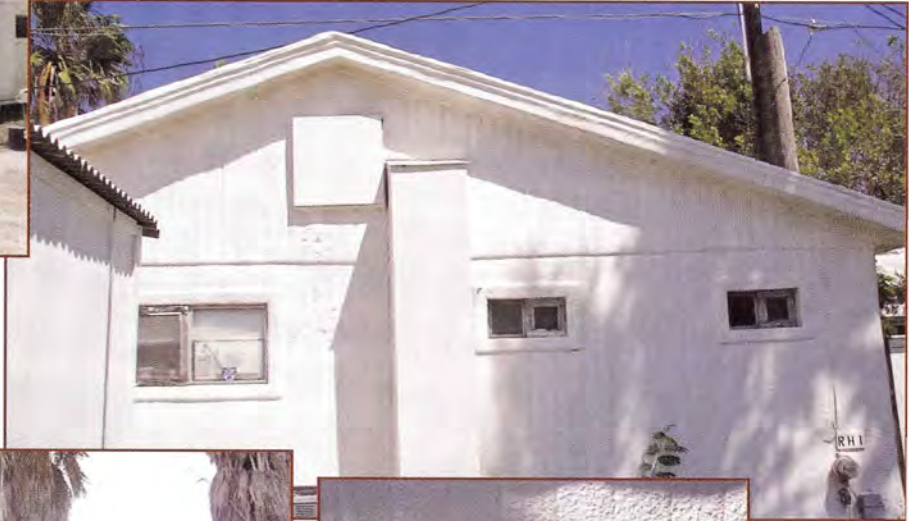
Figure 14 – Same building after Hurricane Dolly in 2009.

In 2009, the building was in the direct path of Hurricane Dolly, with up to 110 mph winds. Again, the building survived with no damage except for a small crack (see Photo 15) and no water intrusion.

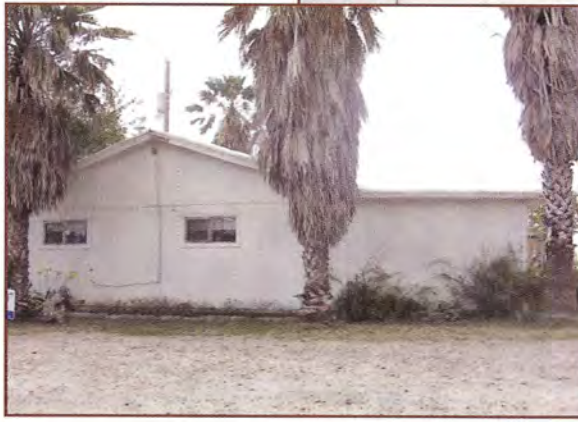
Figure 13 – Same building, 2006.

Park on South Padre Island (one mile from the buildings in Port Isabel) recorded wind speeds in excess of 125 mph. The wood structure survived with no damage and no leaks. Many other buildings in the immediate vicinity were seriously damaged from high winds and water intrusion.

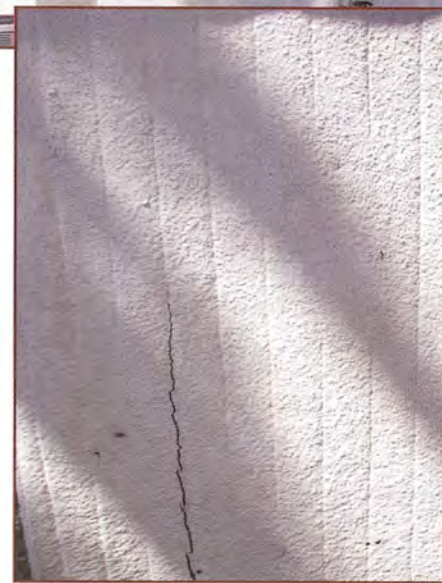
Figure 15 – Only damage after two hurricanes and 30 years of service.

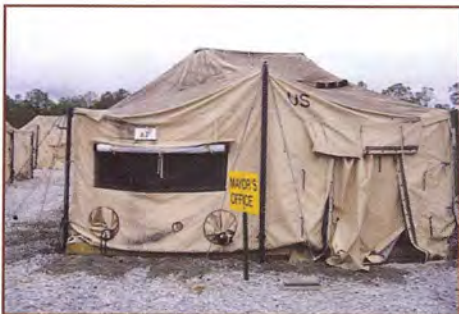
Photo 16 – Example before application of ccSPF.

The Department of Defense (DOD) has an ongoing program to insulate tents and other nonair-conditioned structures in selected bases in Iraq and Afghanistan with 2-lb density ccSPF (Photos 16 and 17). The main goal is to protect against high temperatures in the areas. According to John Siller of the Power Surety Task Force of the DOD, “The foam is providing outstanding performance in this goal.” [Editor’s Note: See “How Insulation Saves Lives and \$\$ in Iraq and Afghanistan” on page 42 for more about this project and the activities of an RCI member

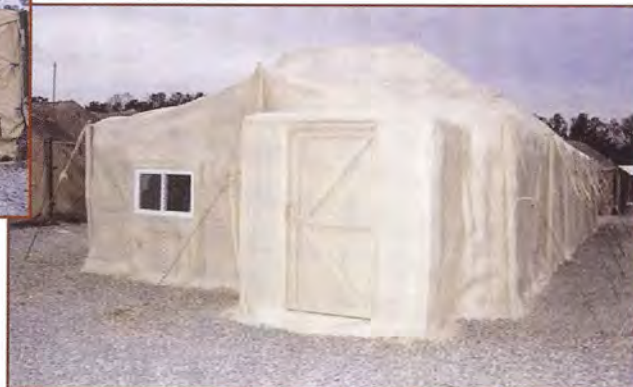
Photo 17 – Example after ccSPF.

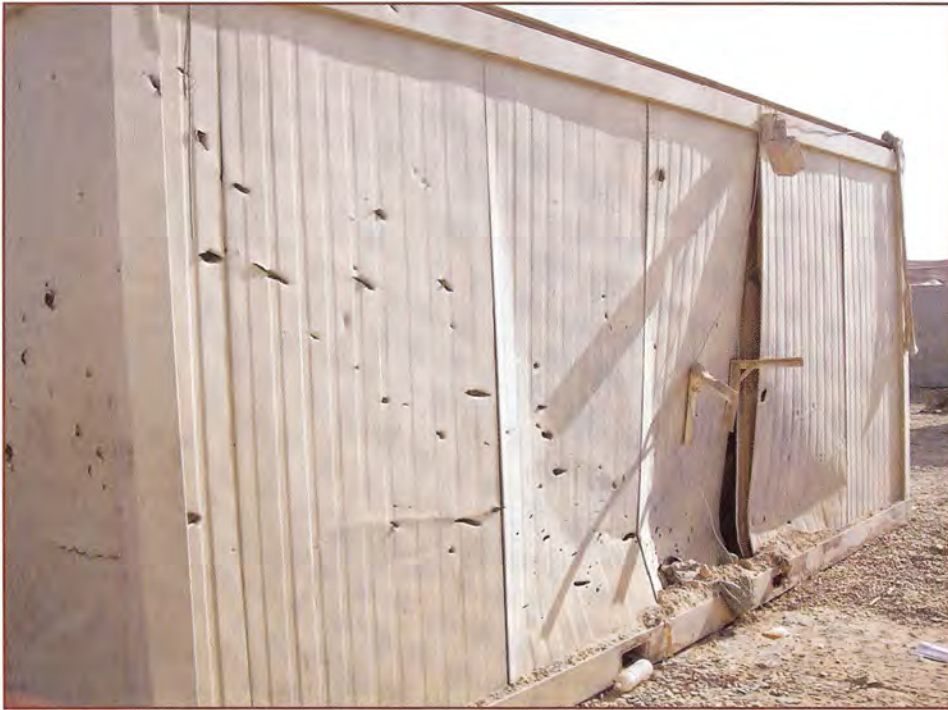
Figure 18 – This metal building was approximately 50 yards from the mortar shell's impact.

But a recent incident may be prompting the military to look seriously at using ccSPF to protect structures against damage from mortars or improvised explosive devices (IEDs). On October 17, 2008, Mearl "Skip" Kline was working with a crew from West Roofing that was insulating tents with ccSPF at a military base just outside the city of Baqubah, Iraq. According to Kline, "The base was attacked by what Army personnel assumed to be 107mm rockets. We hit the ground when we heard the shells coming into the camp. The shells impacted approximately 40 yards from us and 80 to 100 yards away from the ccSPF tents. We were told this type of ordnance has a kill radius of approximately 30 yards. The tents [that were insulated with ccSPF] absorbed shrapnel from the shells without [the shrapnel] penetrating the structures. After the attack, Army personnel were impressed by the

foam's ability to absorb the shock of the shrapnel hits. Many expressed a desire to use the foam to increase the impact resistance from enemy shells." (See Photos 18 and 19.)

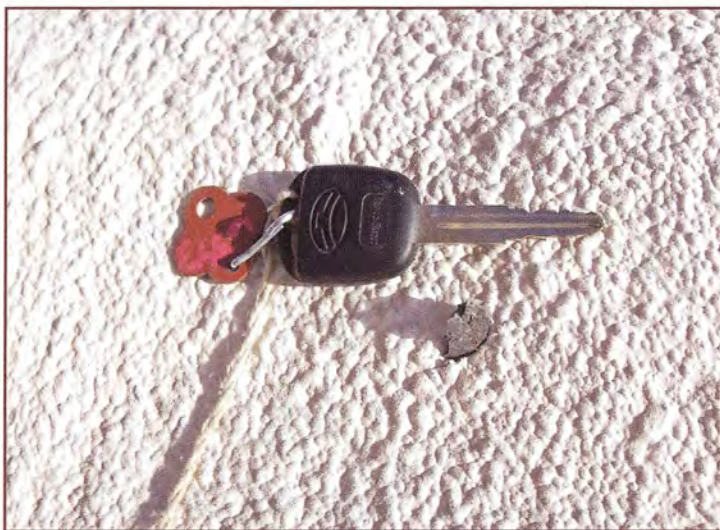
Figure 19 – Shell fragments still capable of severely wounding personnel were embedded in the foam of the structures, 80 to 100 yards away from impact.
