SPF

BEYOND ENERGY INSULATION

By Mason Knowles

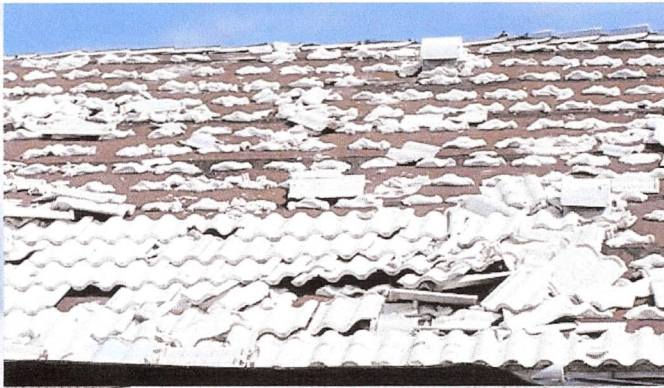
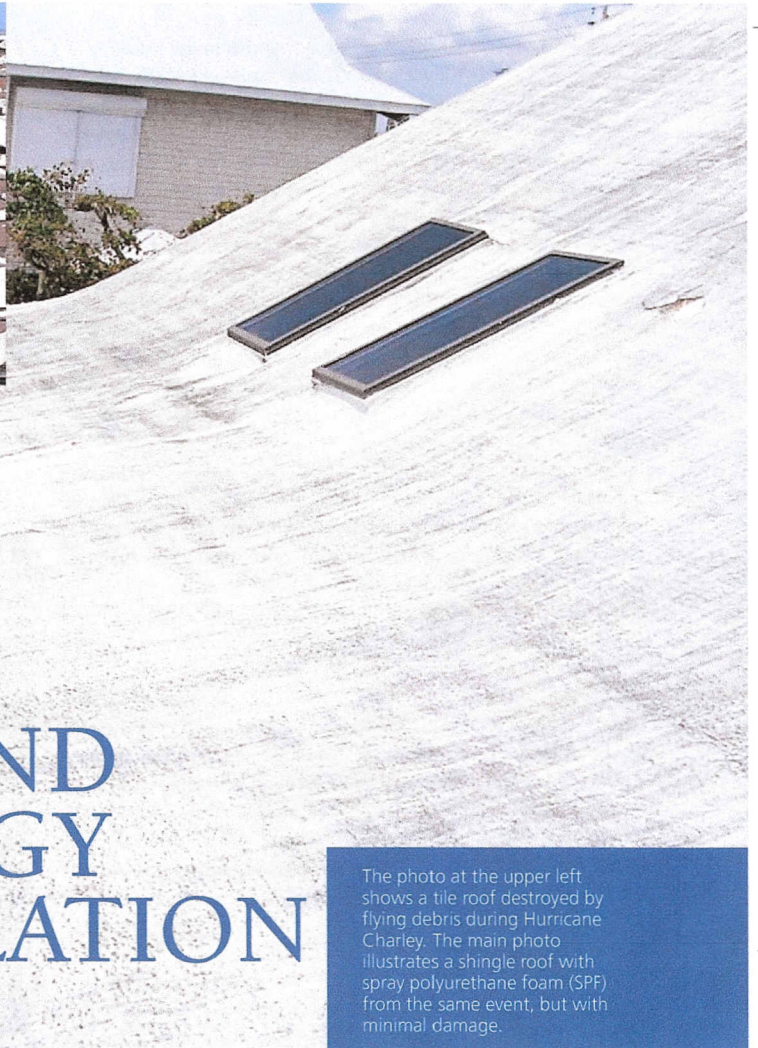
The photo at the upper left shows a tile roof destroyed by flying debris during Hurricane Charley. The main photo illustrates a shingle roof with spray polyurethane foam (SPF) from the same event, but with minimal damage.

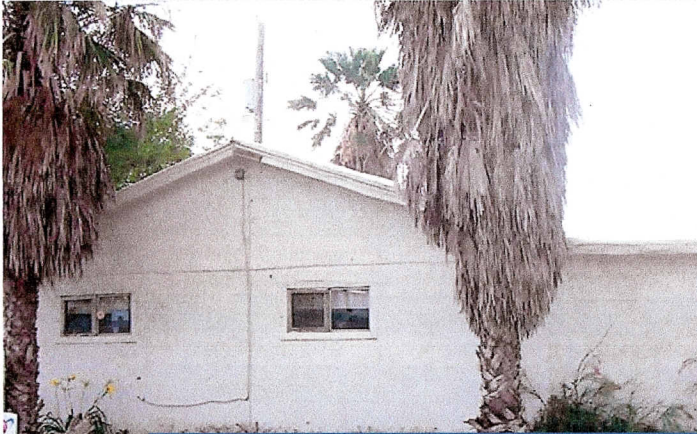
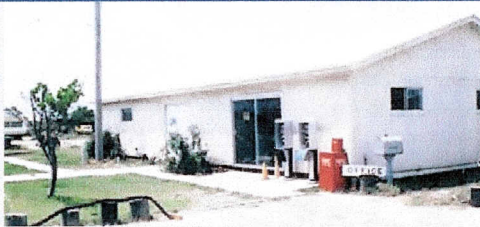
Port Isabel RV Park Office was sprayed with spray polyurethane foam (SPF) in 1979 and survived without leaks and significant damage during Hurricane Allen in 1980. Below is the same building in 2006—no reported leaks in 26 years.

In 1979, John Denney constructed a wood-framed office building at his mobile home park in Port Isabel, but driving rain during frequent tropical storms regularly leaked through the walls. The owner decided to spray the entire outside envelope with SPF. Soon after, Hurricane Allen hit and the building weathered the storm with only superficial damage (easily corrected with a little sealant) and, more importantly, no leaks or structural damage. As shown in this photo taken May 2006, the building still looks the same as the day it was sprayed—it has not leaked since the SPF was installed.

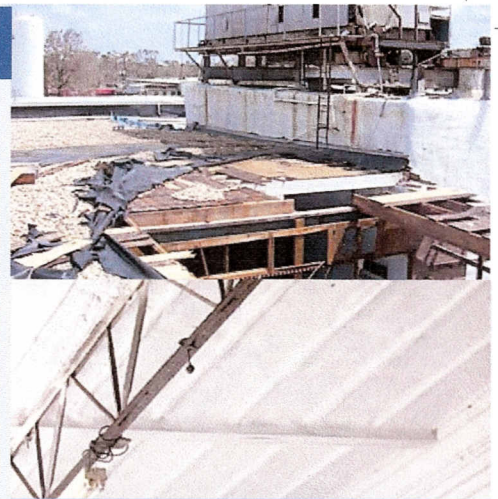
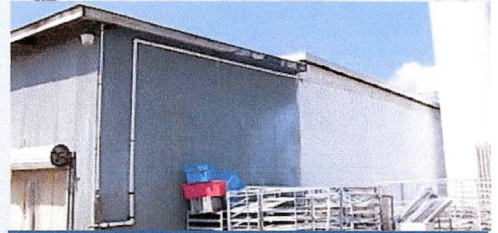
At the Pascagoula Ice Plant in Mississippi, the deck was destroyed by pressurization in areas where no SPF was installed. However, spray foam installed to the interior kept the section of the building in one piece. The exterior also had SPF installed. It shows no damage.

A related example can be found in David Gautier's Pascagoula Ice and Freezer Plant in Mississippi. The ice plant is a 4180-m² (45,000-sf) complex consisting of the original turn-of-the-century building with additional sections added every 20 years or so. The original construction comprised brick walls with wood tongue-and-groove decking.

With its Category 4 winds—200 to 233 km/h (125 to 145 mph)—and an accompanying 7.6 to 9-m (25 to 30-ft) storm surge, Hurricane Katrina destroyed a vast area of the Mississippi Gulf Coast. However, the Pascagoula Ice and Freezer Co. sustained no damage in the SPF-insulated sections. (In places that lacked SPF, pressurization from the high winds blew out portions of the roof deck.)
