INSPECTION, EVALUATION, AND REPAIR OF SPF ROOFING SYSTEMS AFTER A WINDSTORM OR HAIL EVENT

BY MASON KNOWLES AND DON BEST

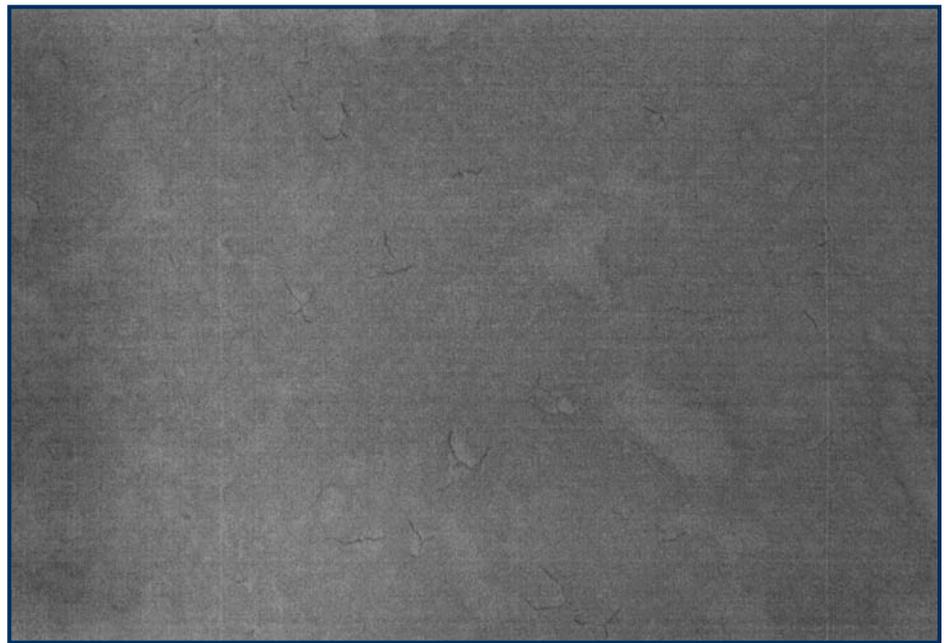
Note the light hail damage requiring recoating.

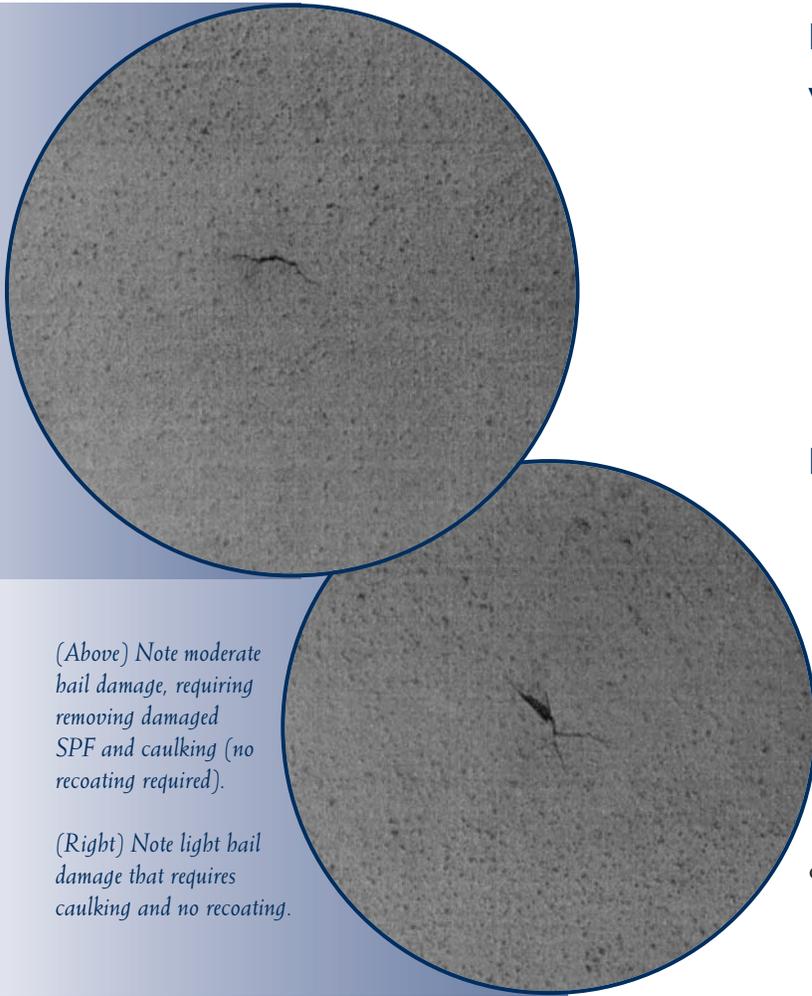
(Above) Note moderate hail damage, requiring removing damaged SPF and caulking (no recoating required).

(Right) Note light hail damage that requires caulking and no recoating.

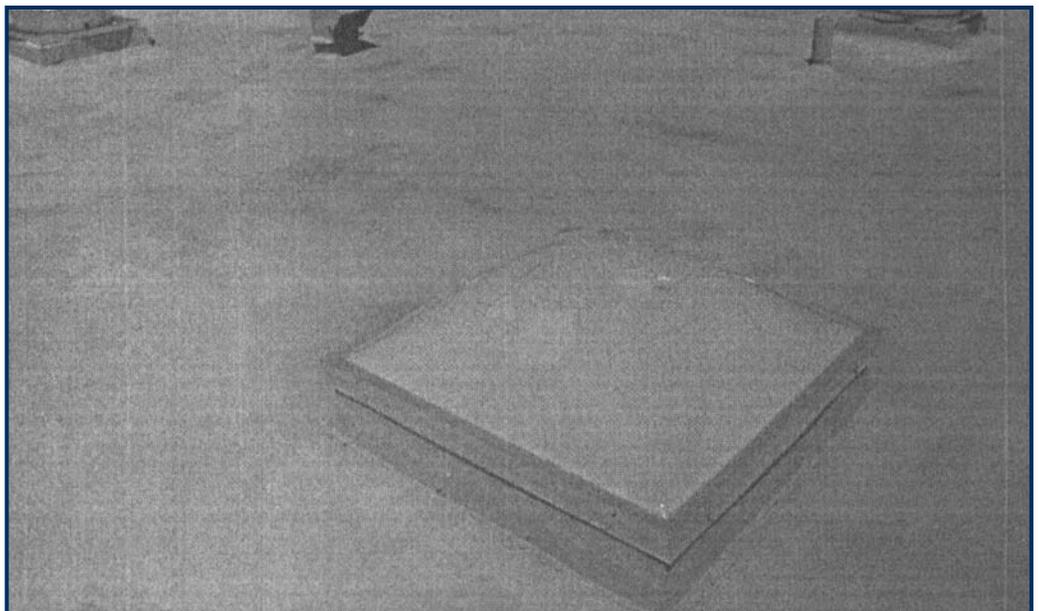
The skylight has been damaged by hail, but the SPF roof exhibits no visible signs of damage.

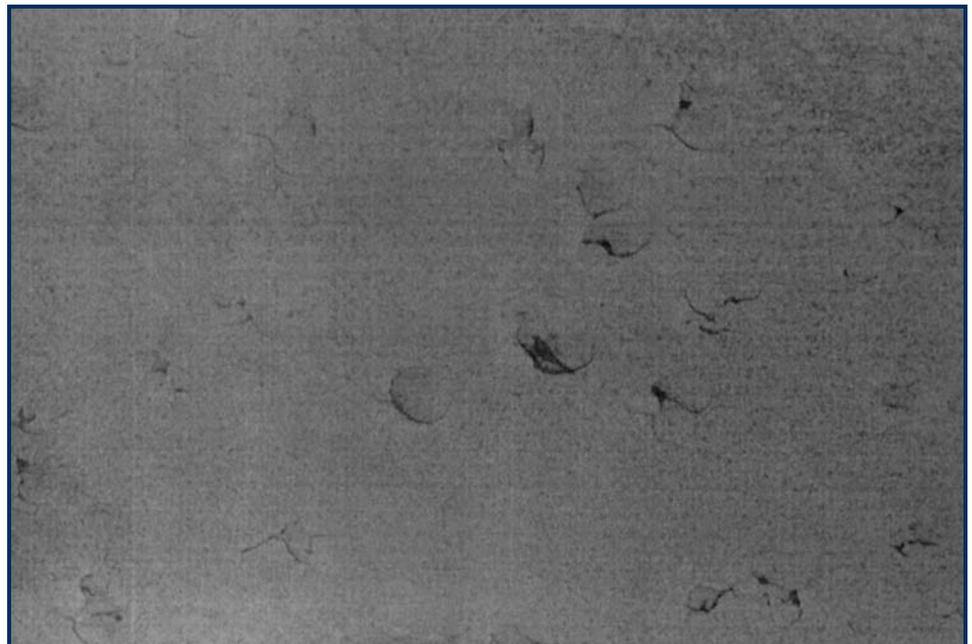
This photo depicts moderate to severe hail damage that would most likely require scarifying the surface, refoaming, and coating.

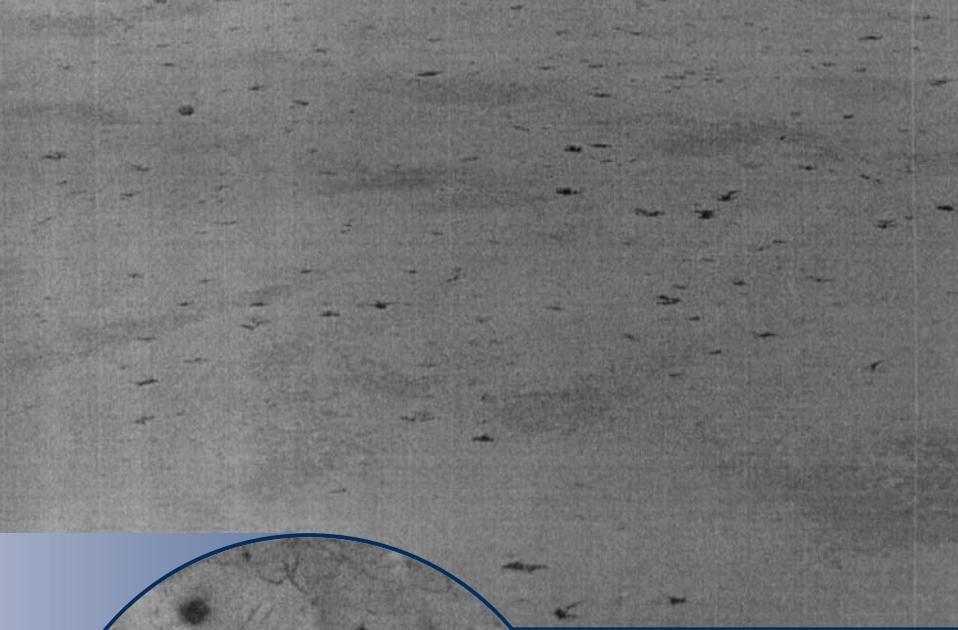
Left: Severe hail damage requiring scarifying of the surface, refoaming, and recoating is pictured.

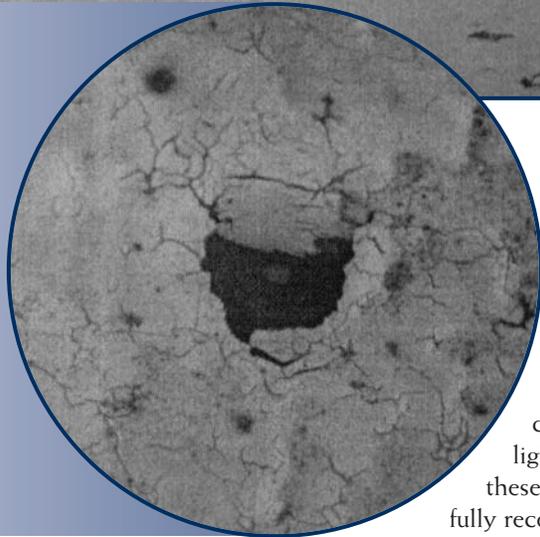
Inset: This photo shows a severe hail dent over brittle coating. Note the many cracks formed by small hail impact. These cracks have been created by the brittleness of the coating. If not for the cracks, the damaged foam could have been removed from the hail hole, and caulked. Because of the numerous cracks, this roof must be scarified, refoamed, and recoated. (Most likely this coating is very old; most coatings will tend to become brittle with age.)
